RESIDUAL SAW DAMAGE IN SILICON WAFERS AND ITS INFLUENCE ON MOS CAPACITANCE RELAXATION

INTERNATIONAL BUSINESS MACHINES CORP.

JULY 1973

TECHNICAL REPORT NO. 2

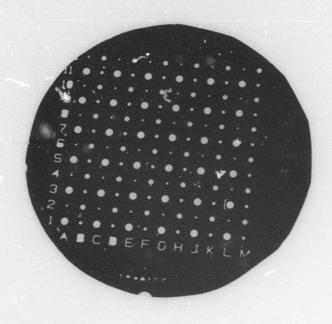
Fig. 1. Photomicrograph of finished wafer.

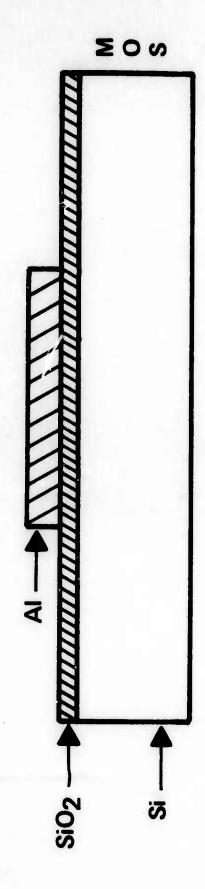
Fig. 2. Cross-sectional view of single finished device.

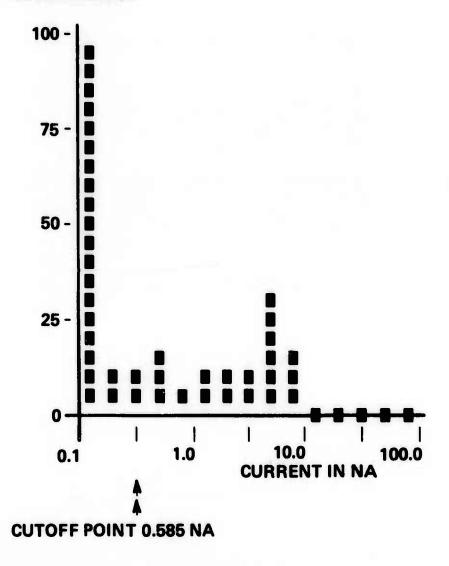
Fig. 5. Example of computer printout — histogram.

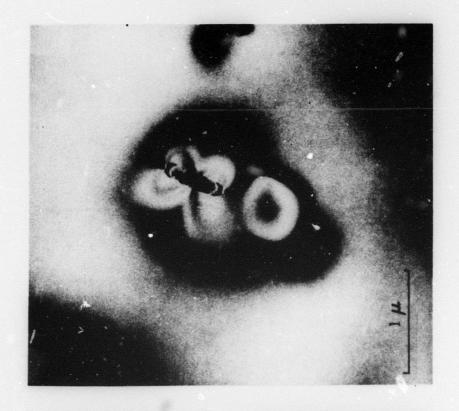
studies were made on numerous good and bad devices. Microsplits were found in bad devices only. Considerable differences in microsplit size for different wafers were also noted. Examples are shown in Figs. 6. After processing and testing of approximately 300 different silicon wafers several general observations were made which can be summarized as follows:

Fig. 6b. Examples of microsplit configurations as found in "bad" devices.

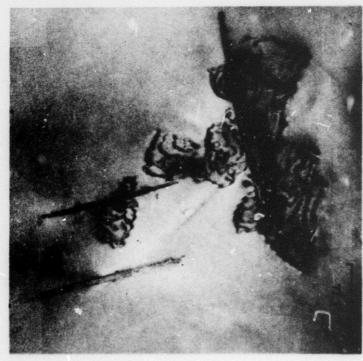
Fig. 6c. Examples of microsplit configurations as found in "bad" devices.

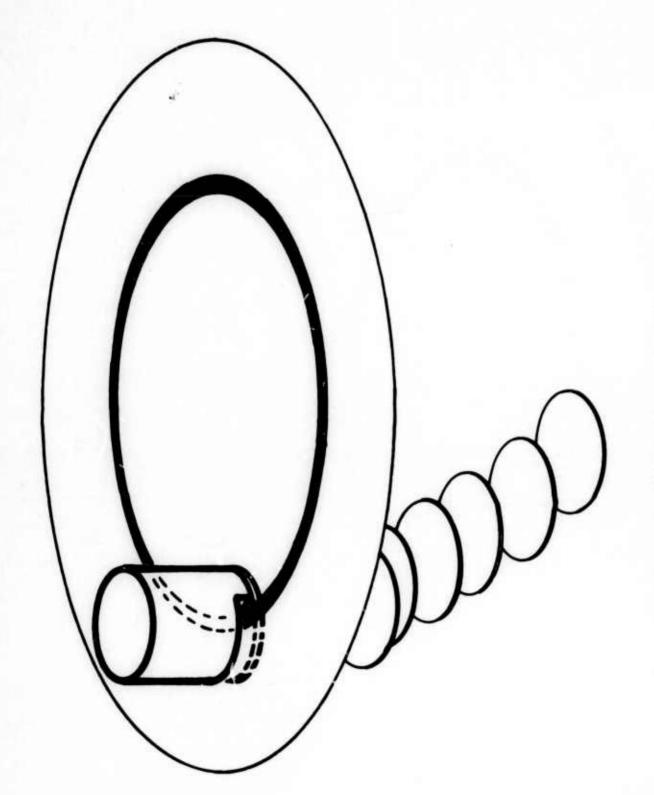
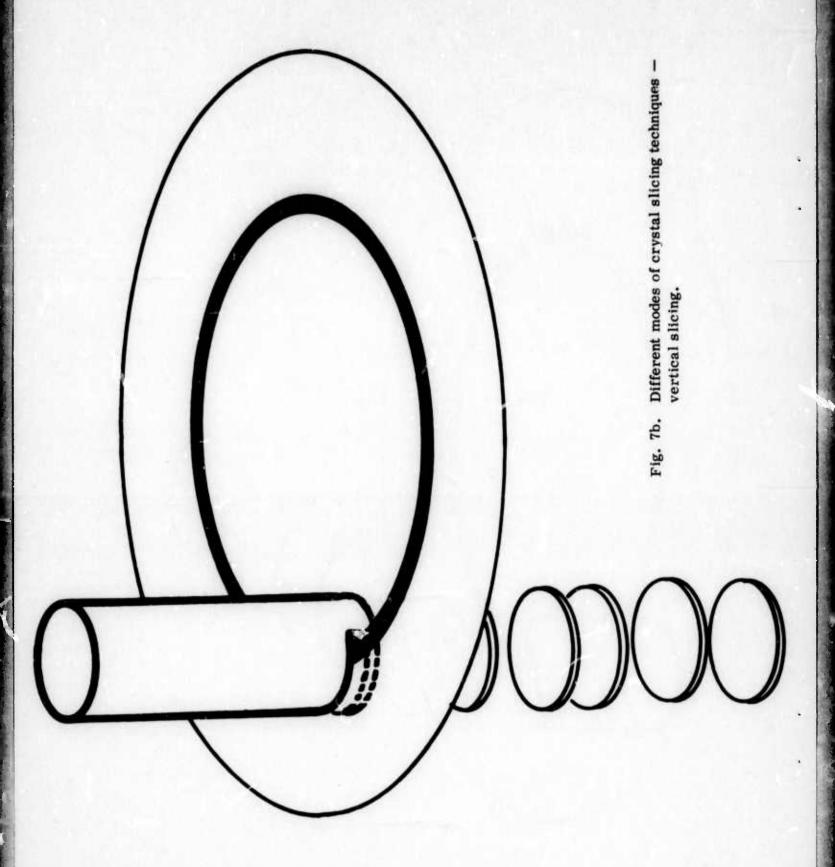
The two different modes of silicon crystal slicing as practiced in industry are shown schematically in Figs. 7 a,b. Two different Czochralski crystals were obtained and sliced by two different vendors as pictured in Figs. 7a and 7b. Care was taken to maintain knowledge of the position of each slice in the crystal after slicing. The silicon wafers were received as-sliced and copper polished by us. After polishing, the crystals were processed as described in section 2.1. The results are summarized in Tables I and II.

Fig. 7a. Different modes of crystal slicing techniques — horizontal slicing.

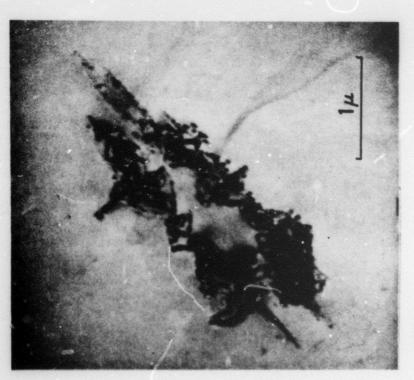
Transmission electron microscopy of bad devices after fast and slow copper polishing reveals interesting differences in the defect size. Representative examples are shown in Figs. 10 a,b. The microsplits are considerably larger in the fast polished wafer. This indicates clearly that the slow polish is much more effective in damage removal than a fast polishing action. This is also confirmed through the good agreement of Syton and copper (alow) polishing results. If both techniques have approximately the same stock removal rate of 1 mil/hour they seem to give identical results.

Fig. 8a. Examples of microsplits as seen in the TEM. Typical for fast polishing.
